Results of the Olmsted Hydraulic Operated Wicket Dam

By: Rick W. Schultz P.E., U.S. Army Corps of Engineers

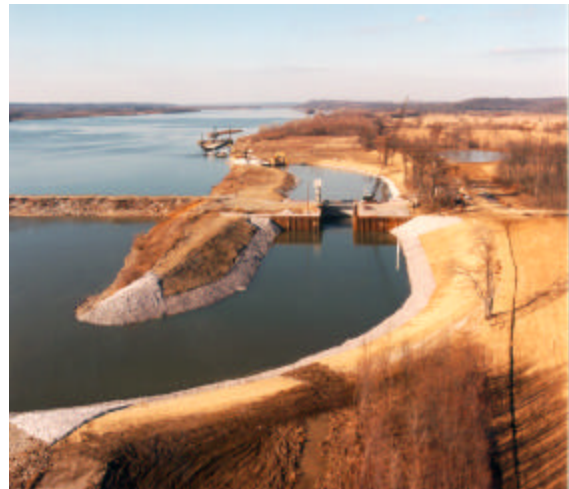
Aerial view of Prototype

The Olmsted Prototype hydraulic operated wicket dam was constructed on the Kentucky bank of the Ohio River. A 1,100 foot (335.28 meter) long, 250 foot (7.62 meter) wide approach channel and 600 foot (182.88 meter) long retreat channel was dug to bring the Ohio River to and from the site. Construction began in May of 1994 and

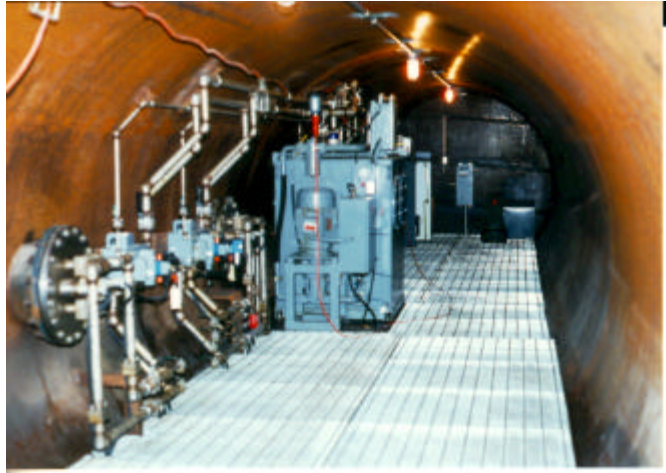
Inside

of Gallery

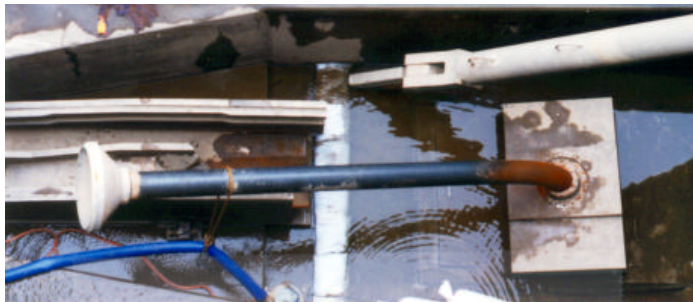
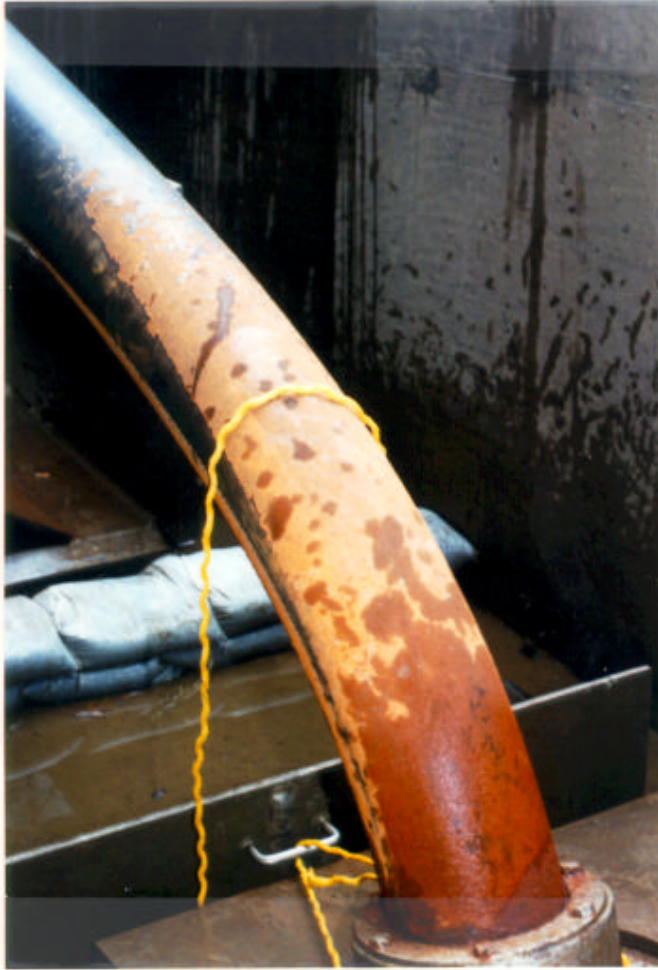
One of the wickets malfunctioned during the testing phase, causing the hydraulic piston rod on the lifting cylinder to be bent. The cause of the malfunction was the jamming of a prop which caused a chain reaction of events to occur. The wicket was being operated with high tail water, which meant the hydraulic cylinder was not visible. The cylinder was retracting, lowering the wicket, and when the prop jammed the cup and ball connection between the piston rod and wicket separated. This caused the wicket to jam in the raised position causing a small alignment cylinder piston rod to break and eventually side loading on the large piston rod caused

the rod to bend. The diameter of the piston rod was 7.5 inches (190mm) and was made of HR4140 alloy steel (100,000 yield) with a .022 inch (.56mm) thick ceramic coating. The photos show the aftermath of the bent rod.

Bent Piston Rod

Base of Bent Rod

Lessons learned from the damage were: First, to prevent this from occurring in the future, provide as much clearance as possible with large moving parts. Second, despite tremendous bending loads on the piston rod the ceramic coating was only damaged at the extreme bend in the rod. Cracks in the coating were observed along the tension side of the rod. The piston rod bent to a radius of approximately 5 feet (1.52 meters) and the coating flaked off along the bend. The rest of the rod was still in good condition. Third, the damage to the cylinders were in no way related to the manufacturing or design of the cylinders but are an important lesson learned on the durability of the ceramic coating and the catastrophic events which can occur to a piston rod.

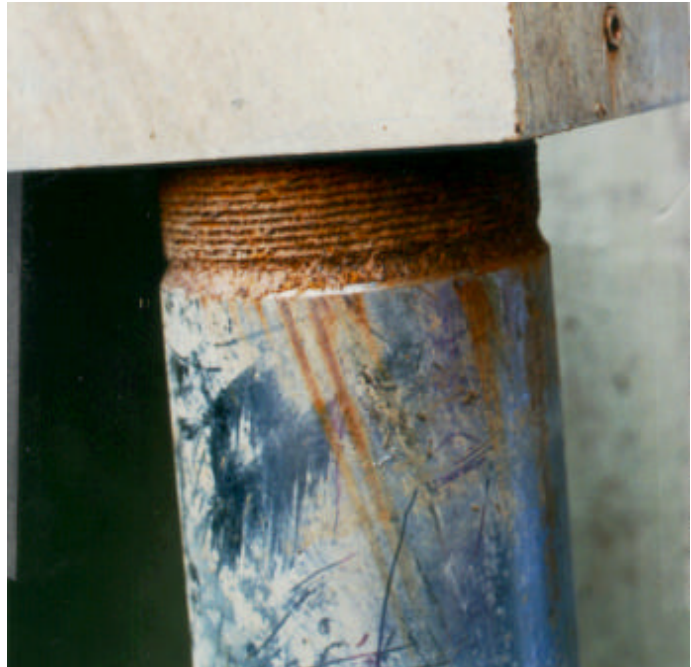
Two of the cylinder manufacturers, Rexroth Hydraudyne. and Hunger Cylinders, took special care in designing an O-ring seal to protect the threads on the end of the piston rods from water and debris getting into the threads. The other manufacturers did not and corrosion was extreme on the exposed carbon steel threads. The photo shows a typical unprotected piston rod after just seven months of exposure.

Corroded Threads on Piston Rod

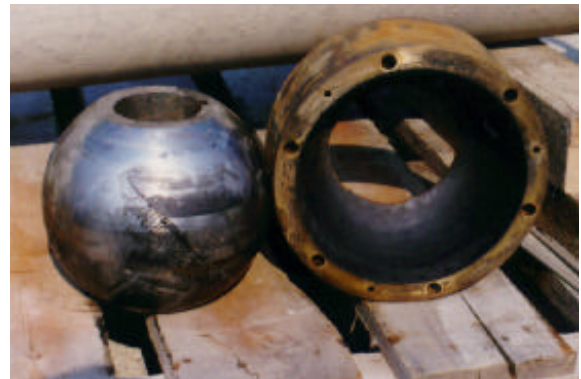
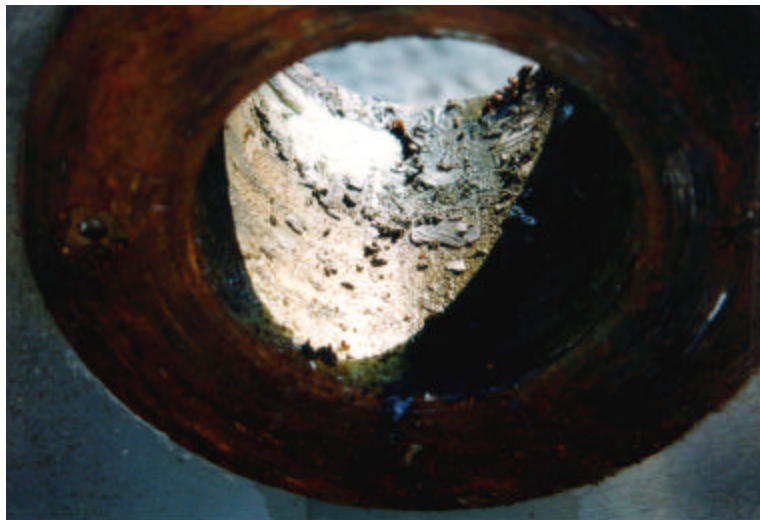
Wicket #2

Kamatics Bearing failed dramatically. The inner lubricating material flaked off the housing of the bearing. The manufacturer stated they made a mistake in the design of the bearing for the test.

Inside of Kamatics Bearing After Test

The lubricant material also flaked off the inside of the race of the prop bearing.

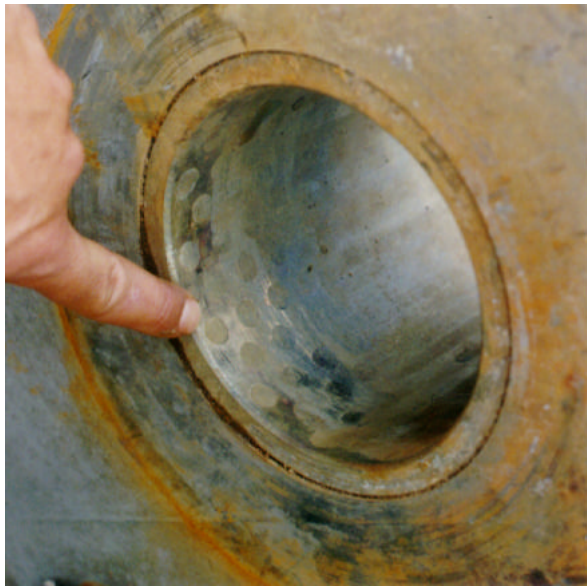
Merriman Lubrite had begun to lose its inner lubricating surface.

Merriman Lubrite Bearing

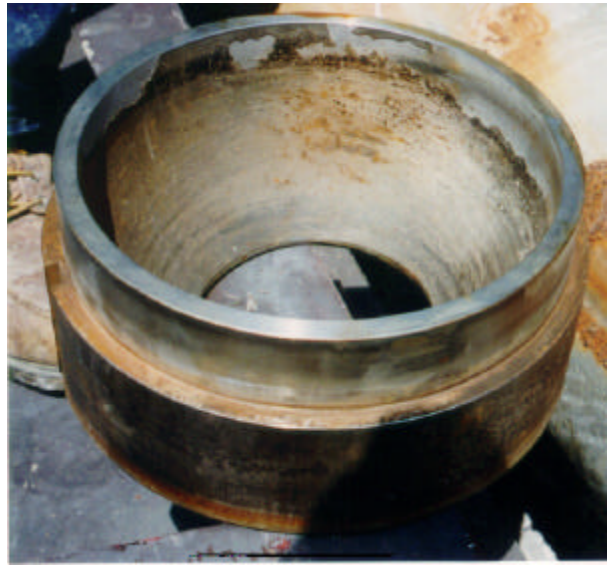
**Inside Race of Kamatics Bearing
Note lubricant flaked off.**
